**BEA**  
Bureau d'Enquêtes et d'Analyses  
pour la sécurité de l'aviation civile

Objet : FDR Preliminary Sequence of Events

V/réf : 30/05/2008 A320 EI-TAF TACA accident in Tegucigalpa Airport

### Preliminary sequence of events from DFDR

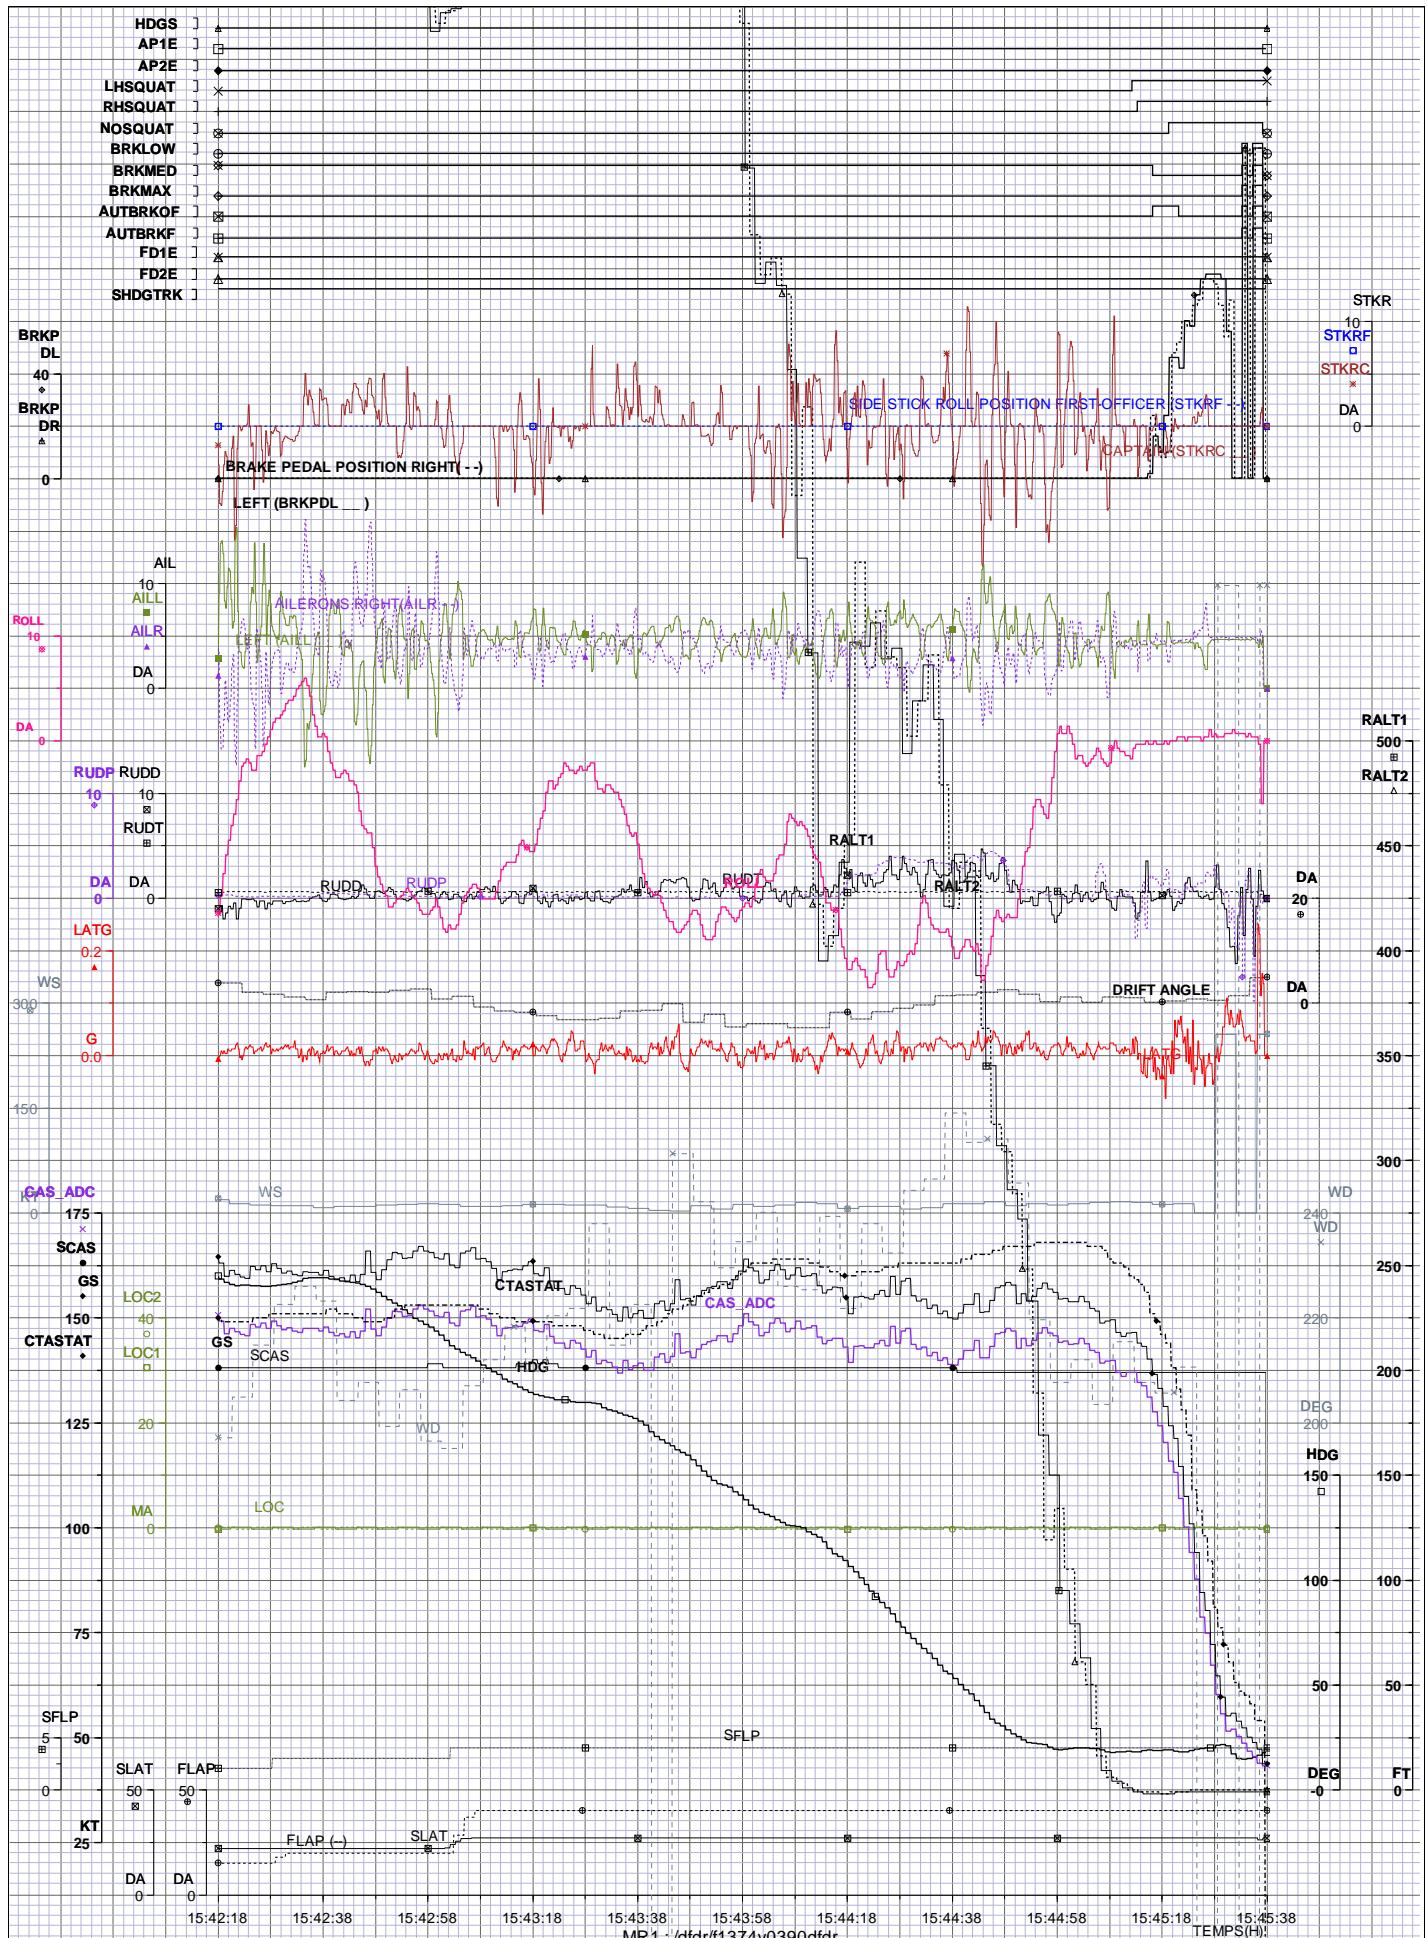
Figure 2.2

## APPROACH (LATERAL AXIS)

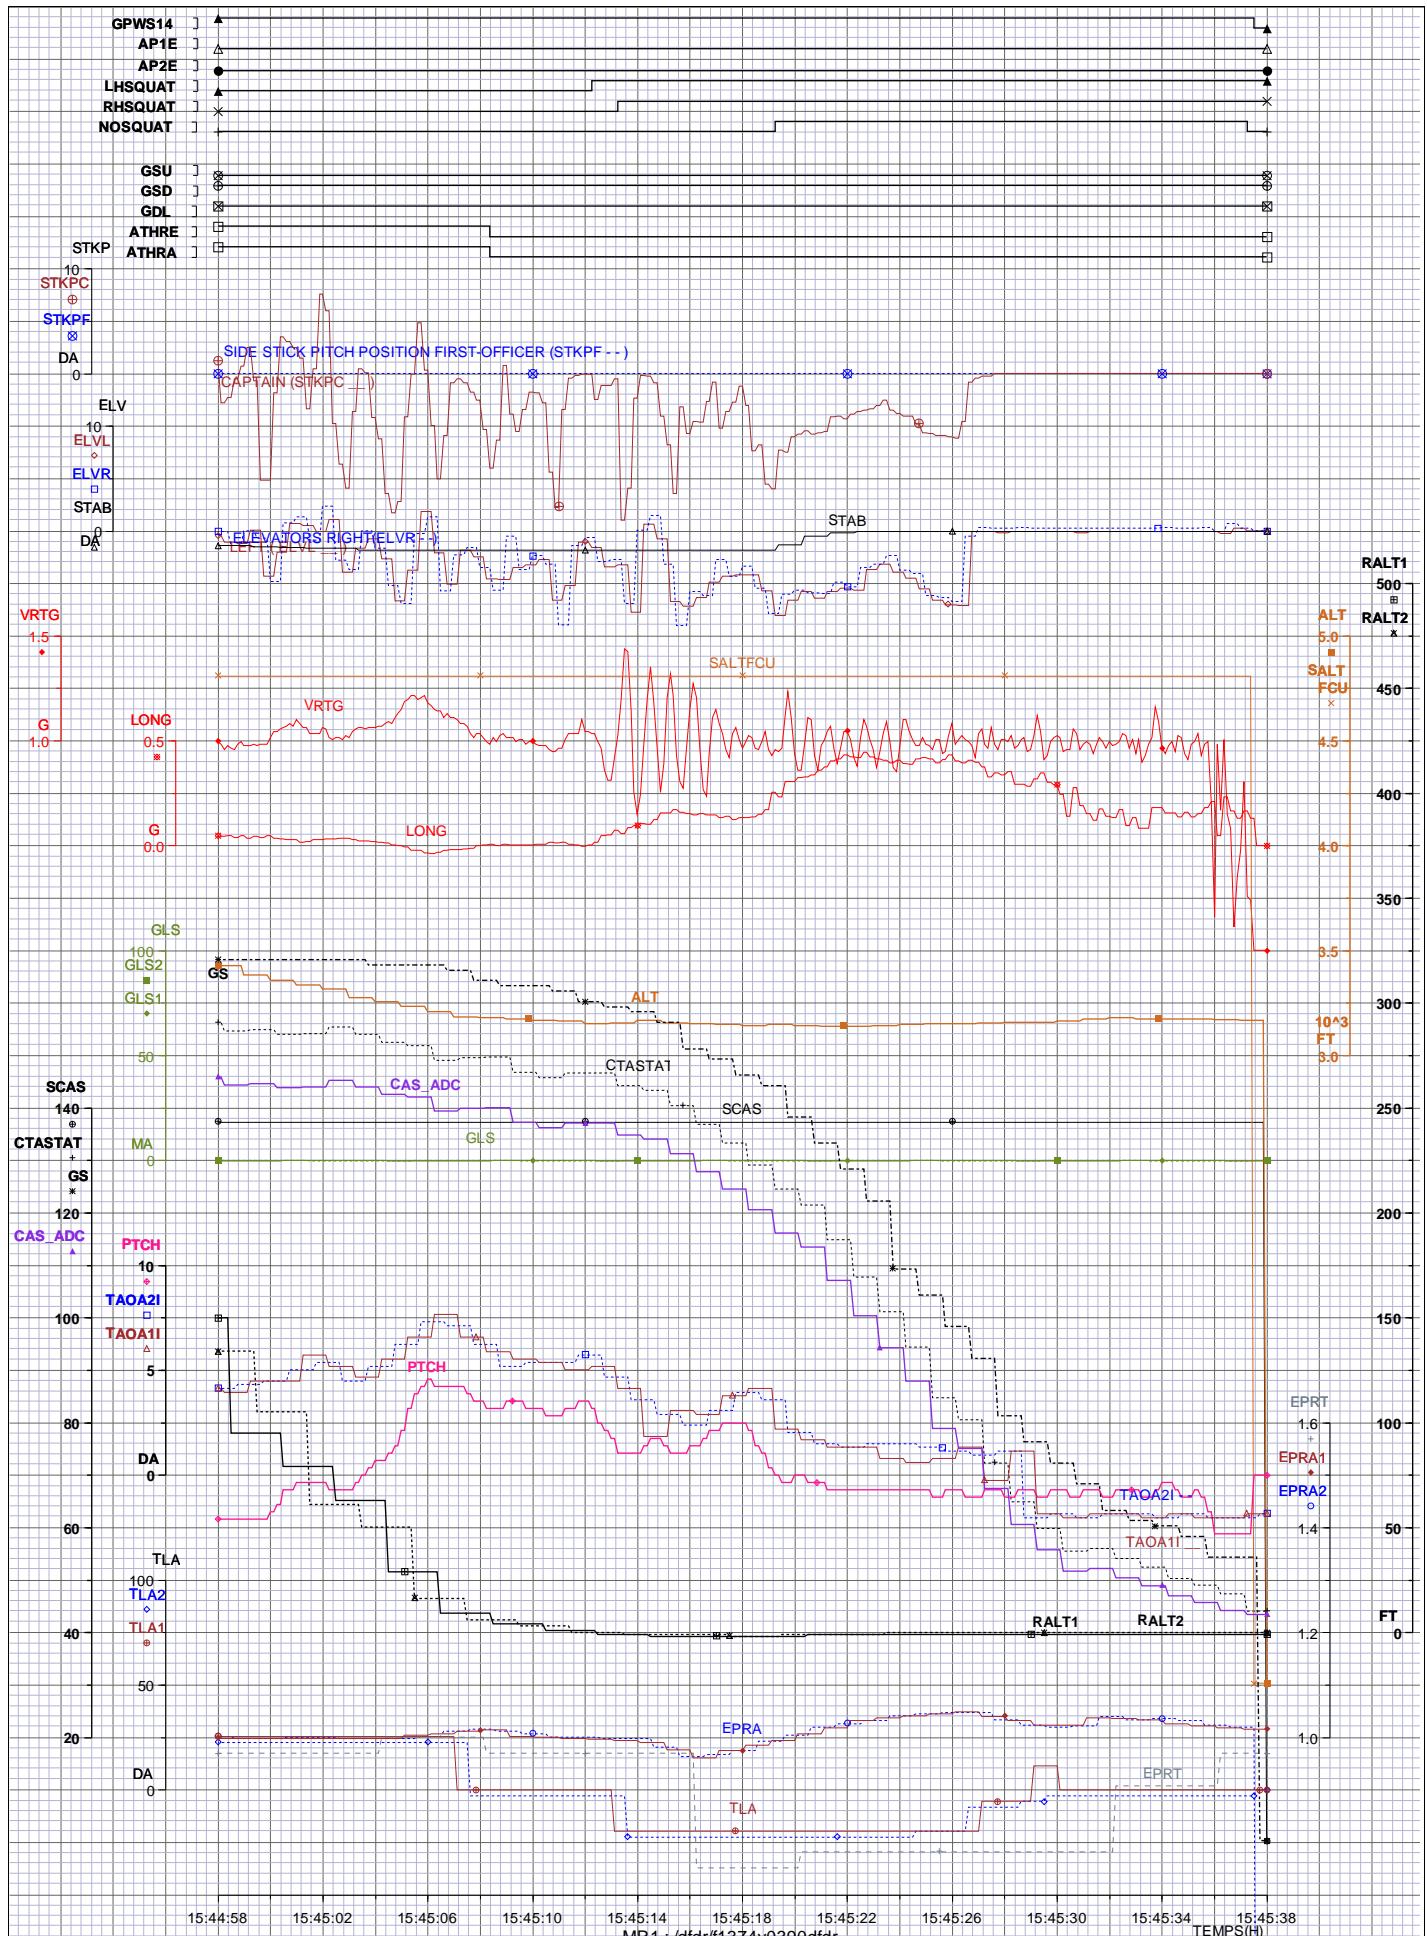
Figure 3.1

## APPROACH (LONGITUDINAL)

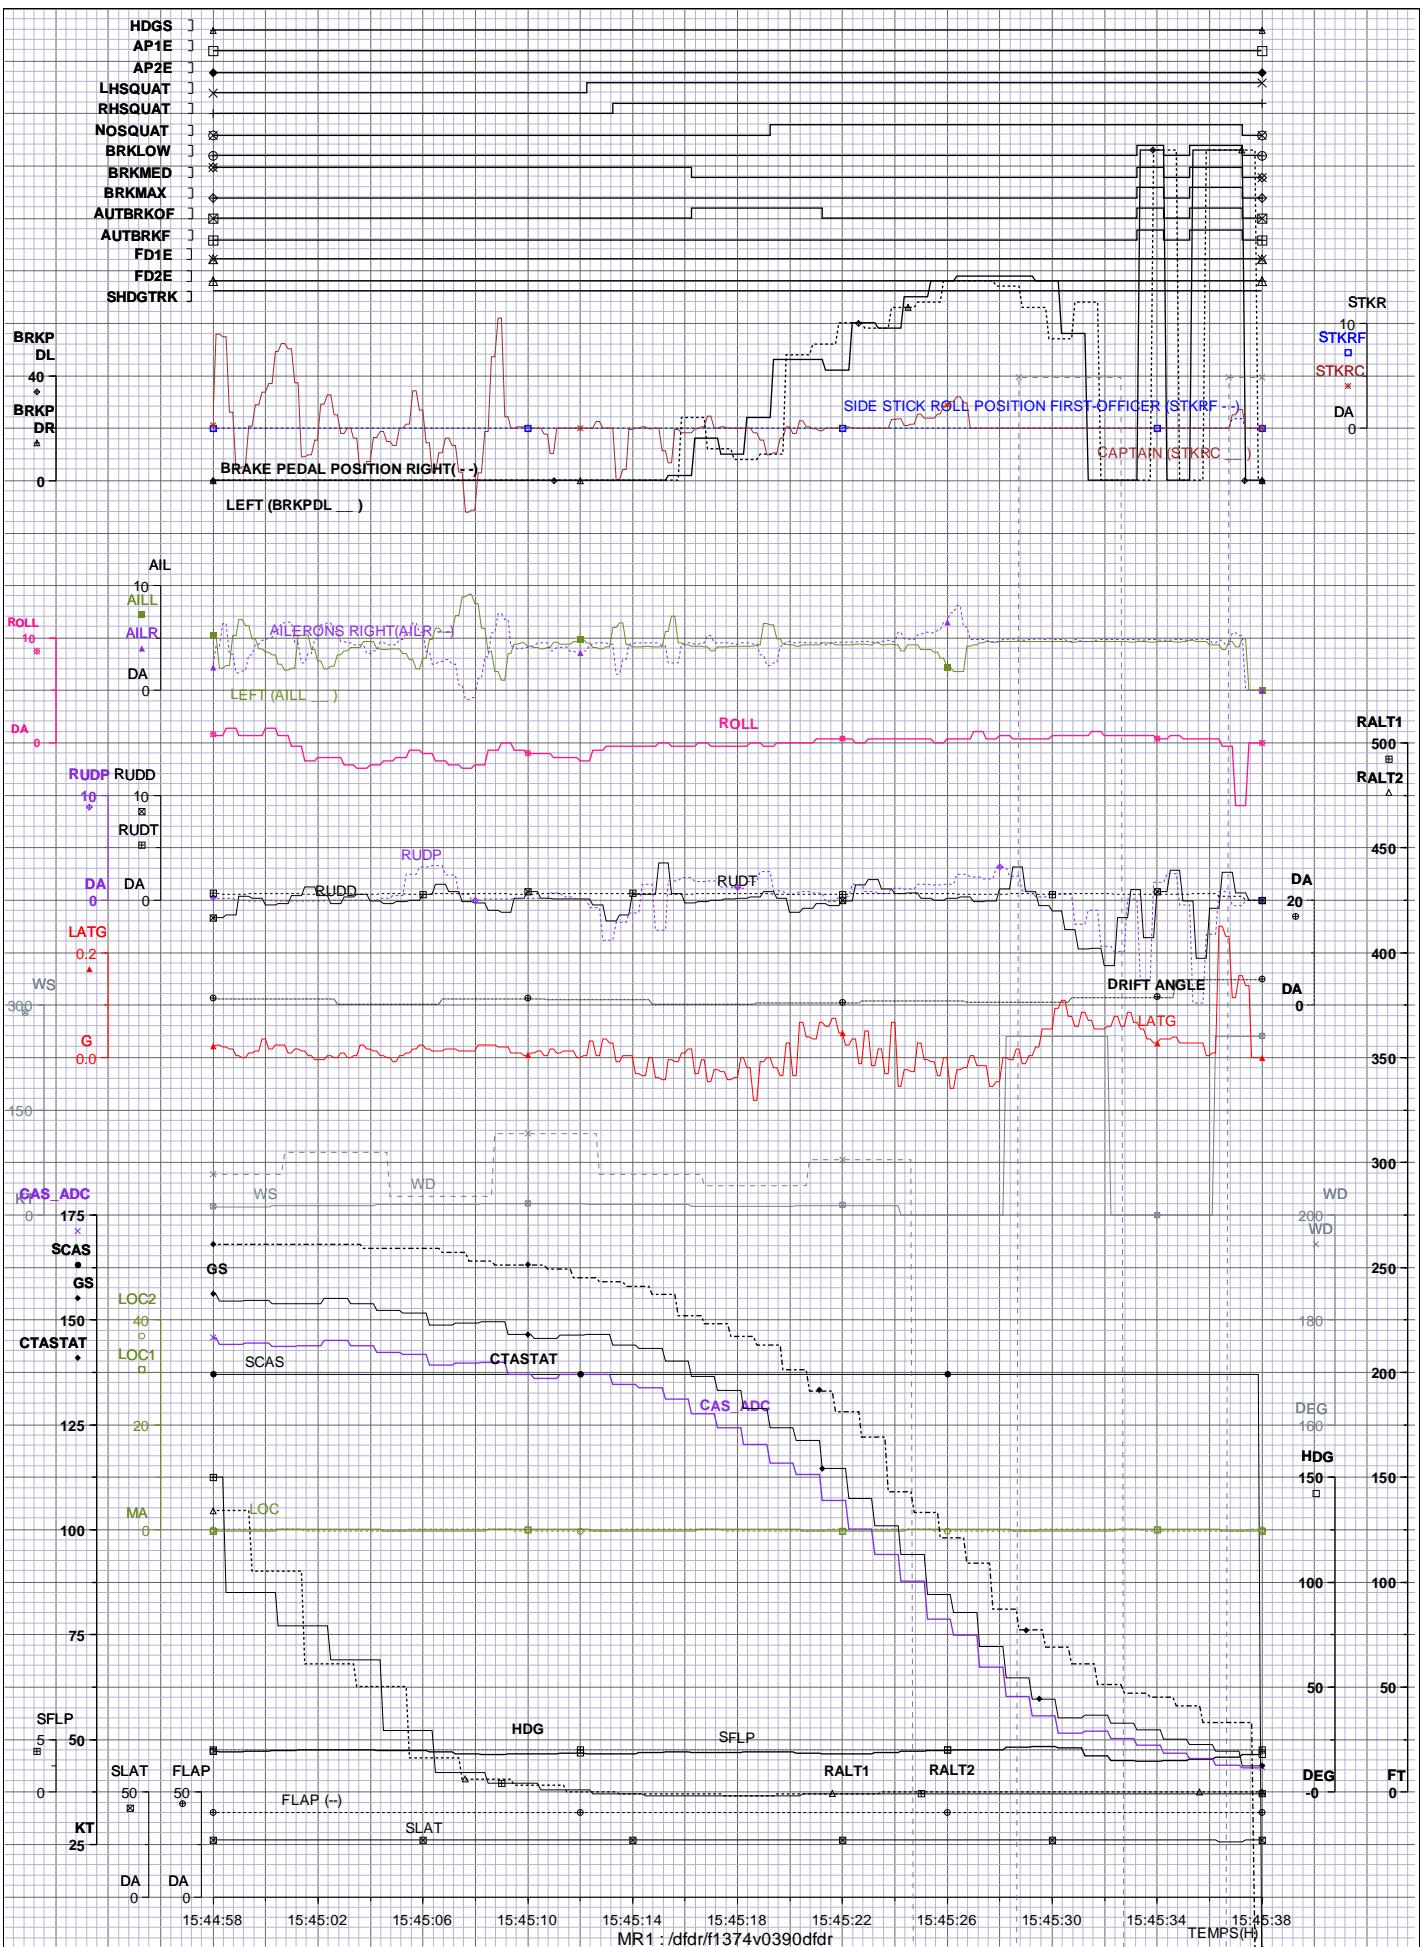
## **APPROACH (LATERAL AXIS)**

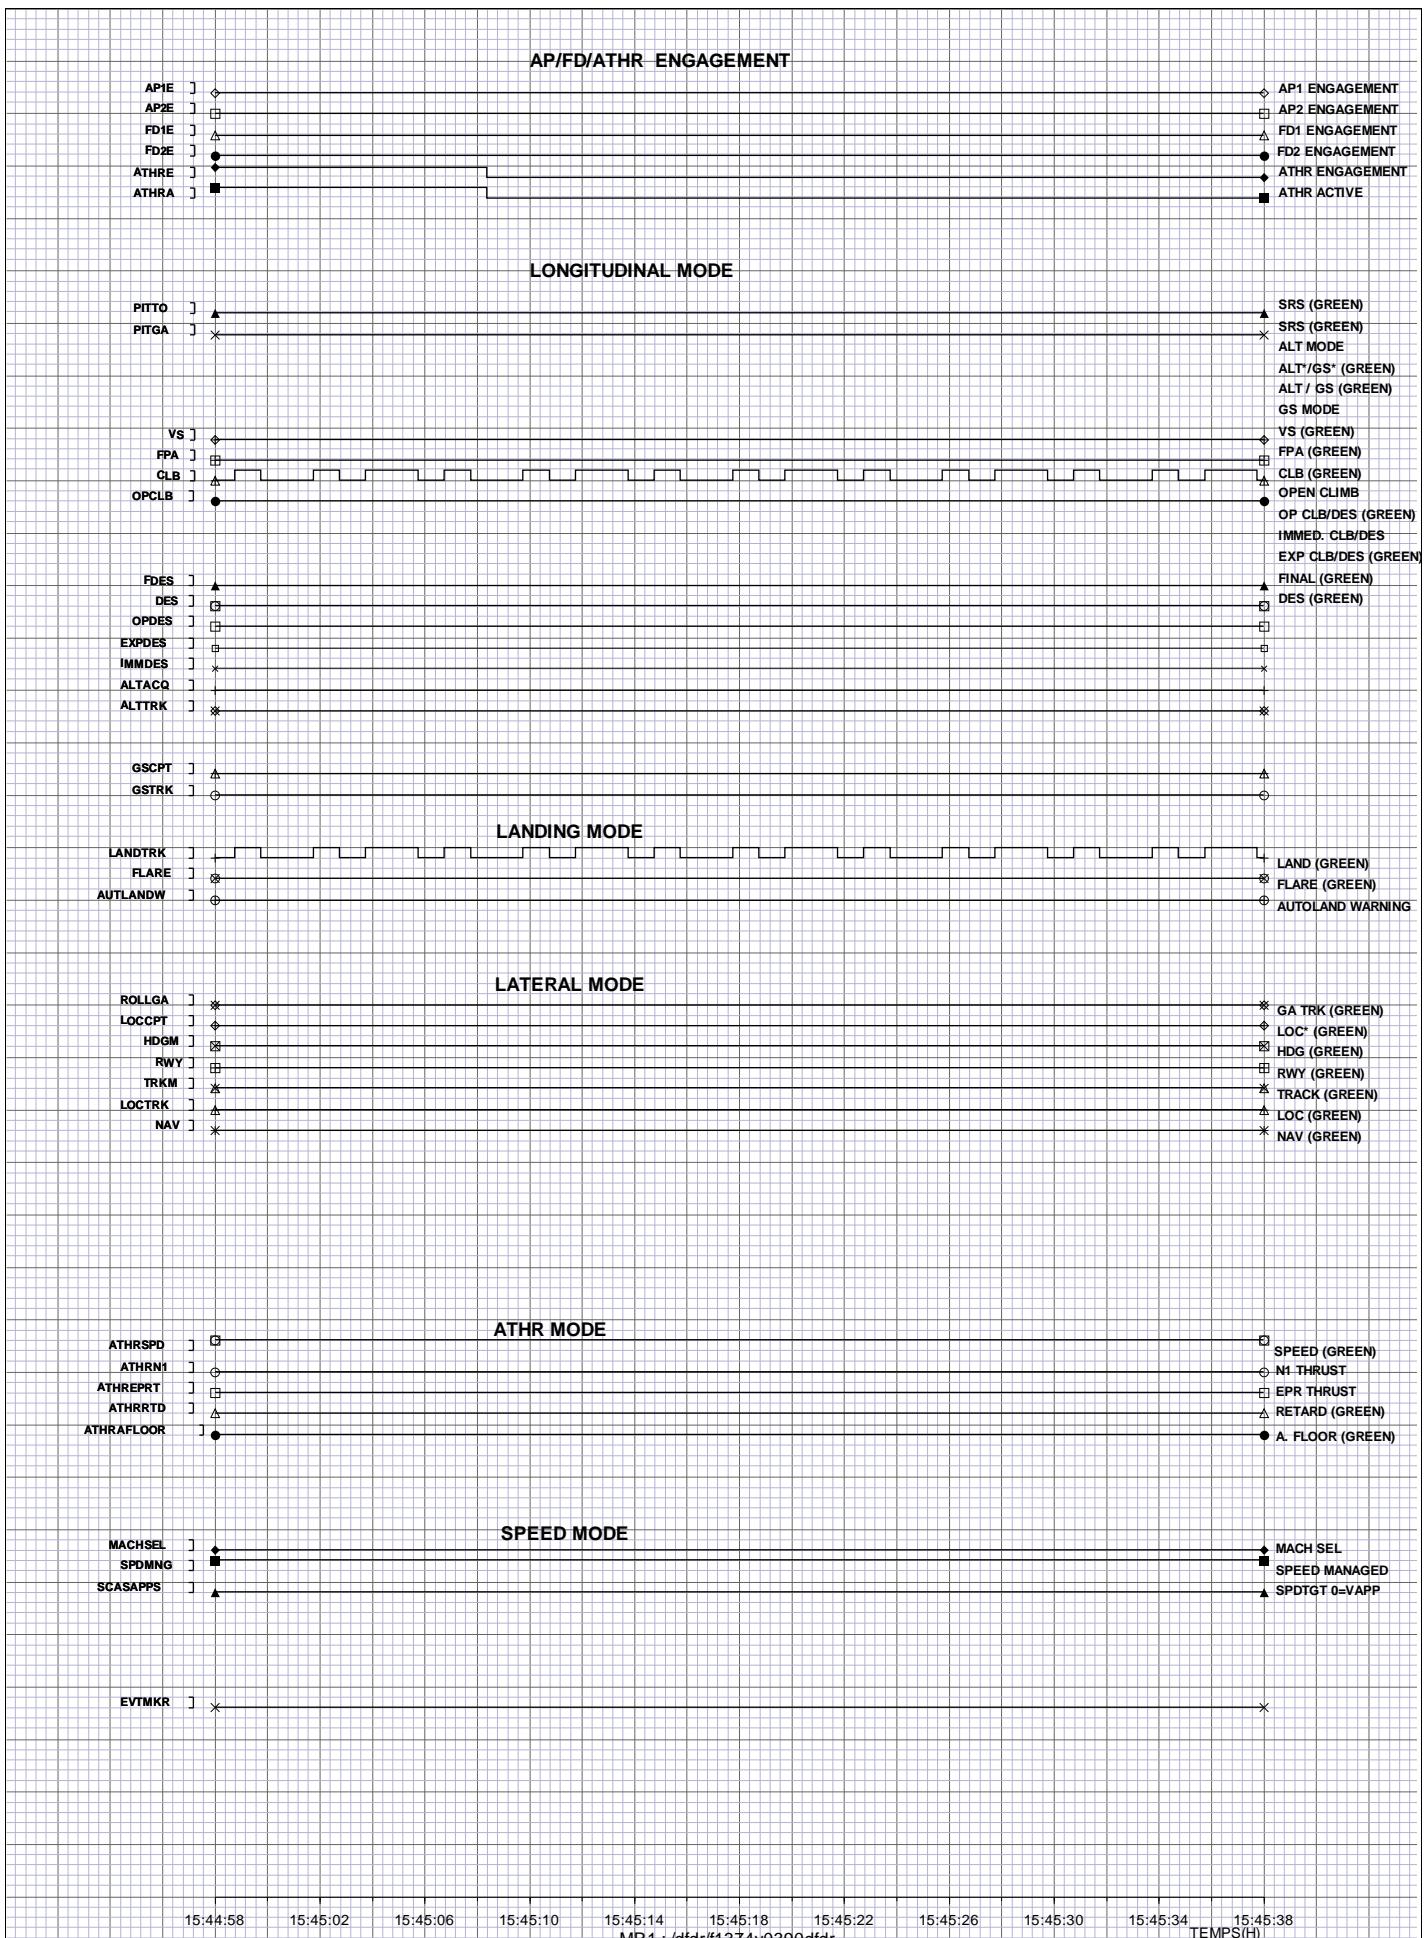
**SA A/P MODES**

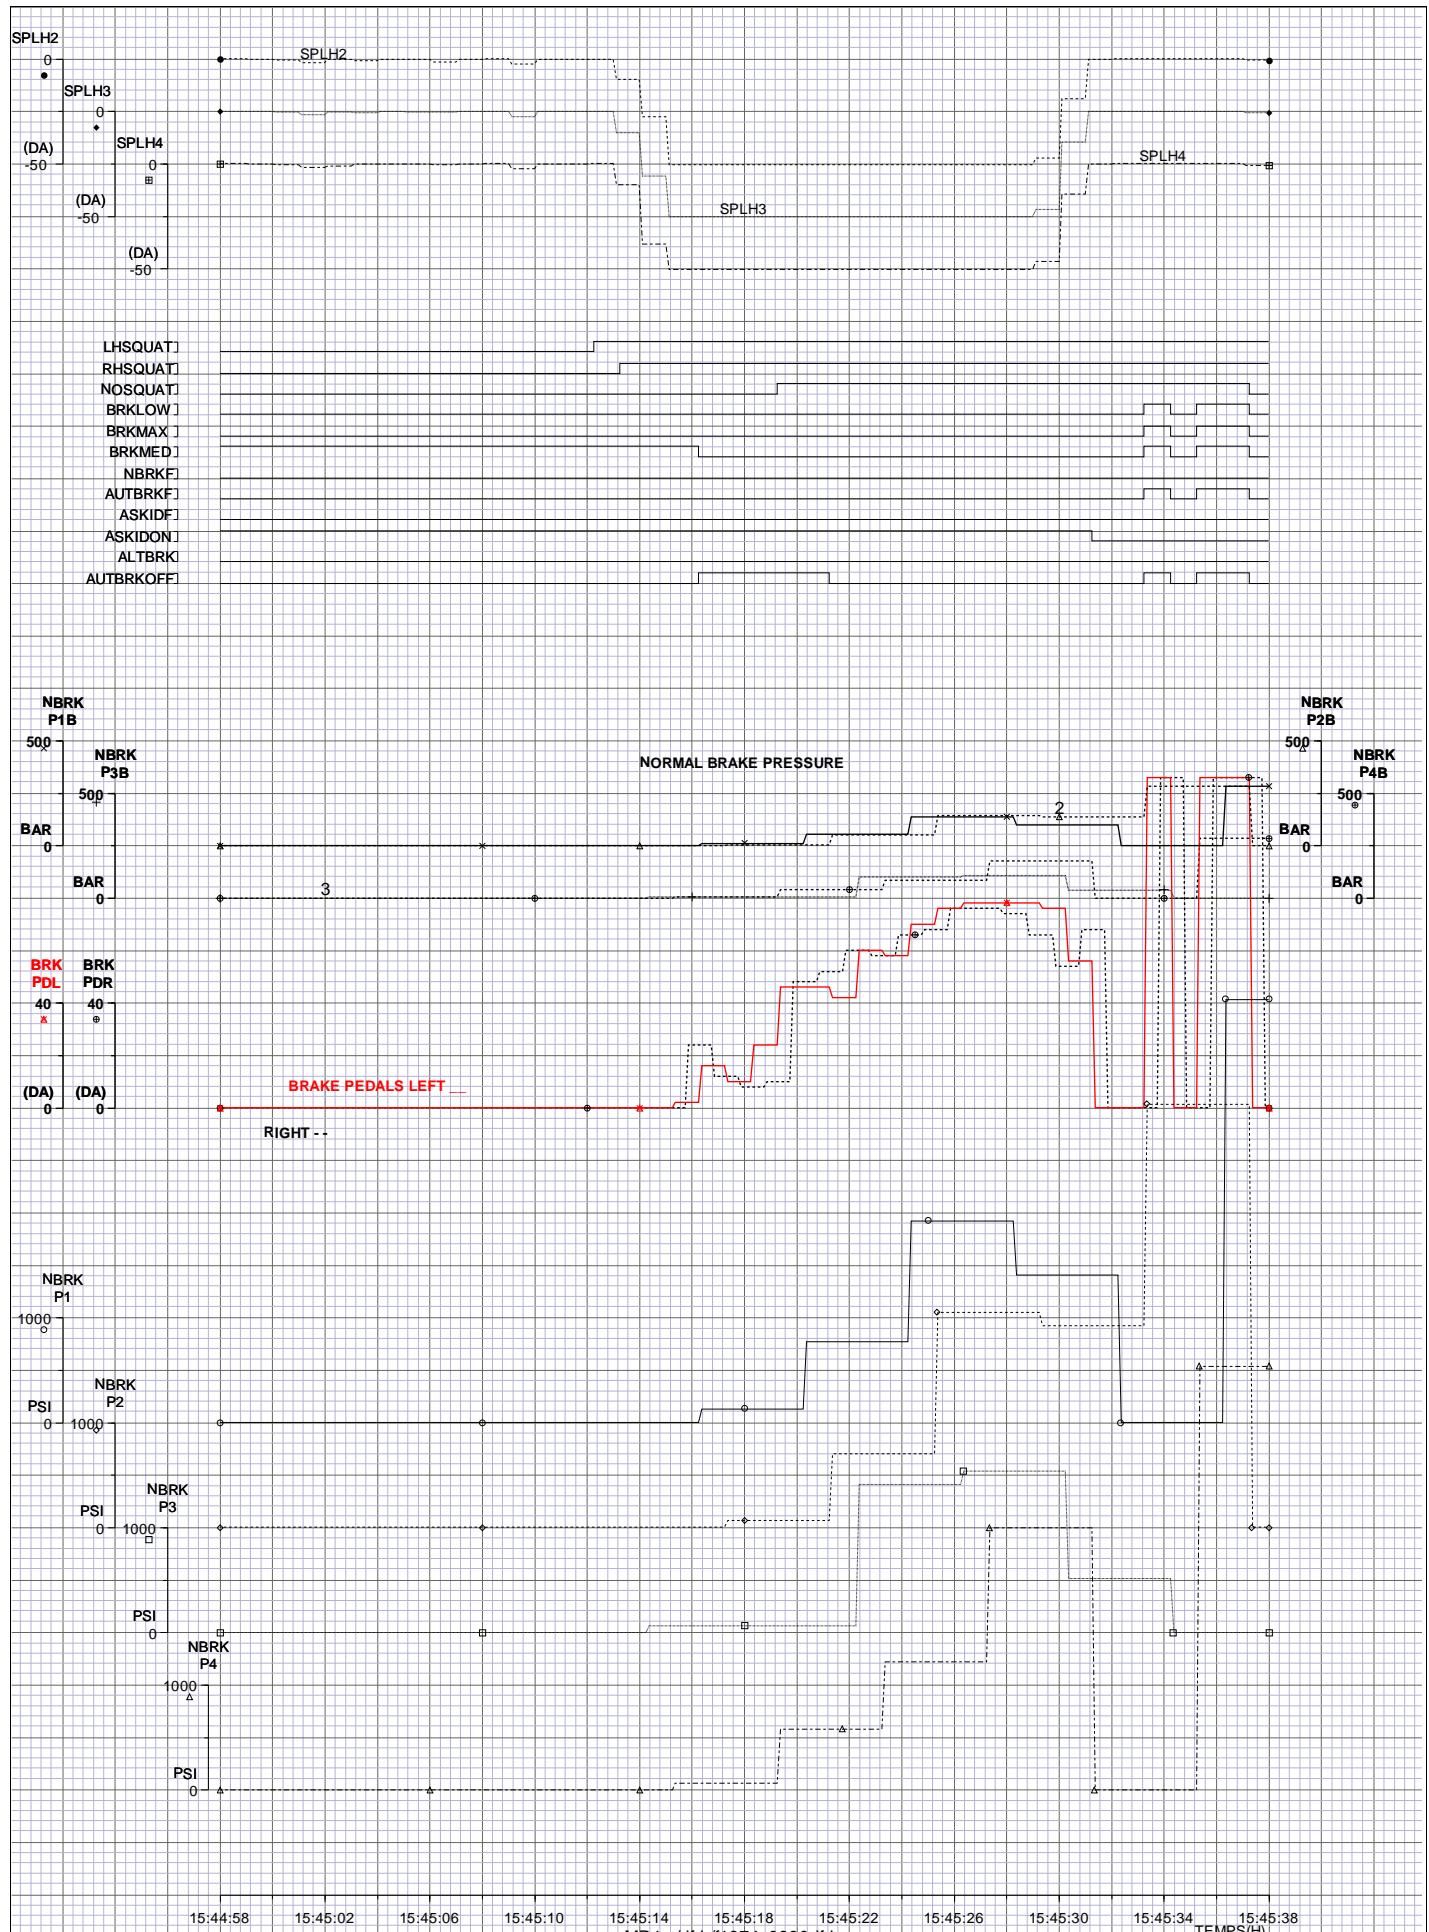
## BRAKE PRESSURES

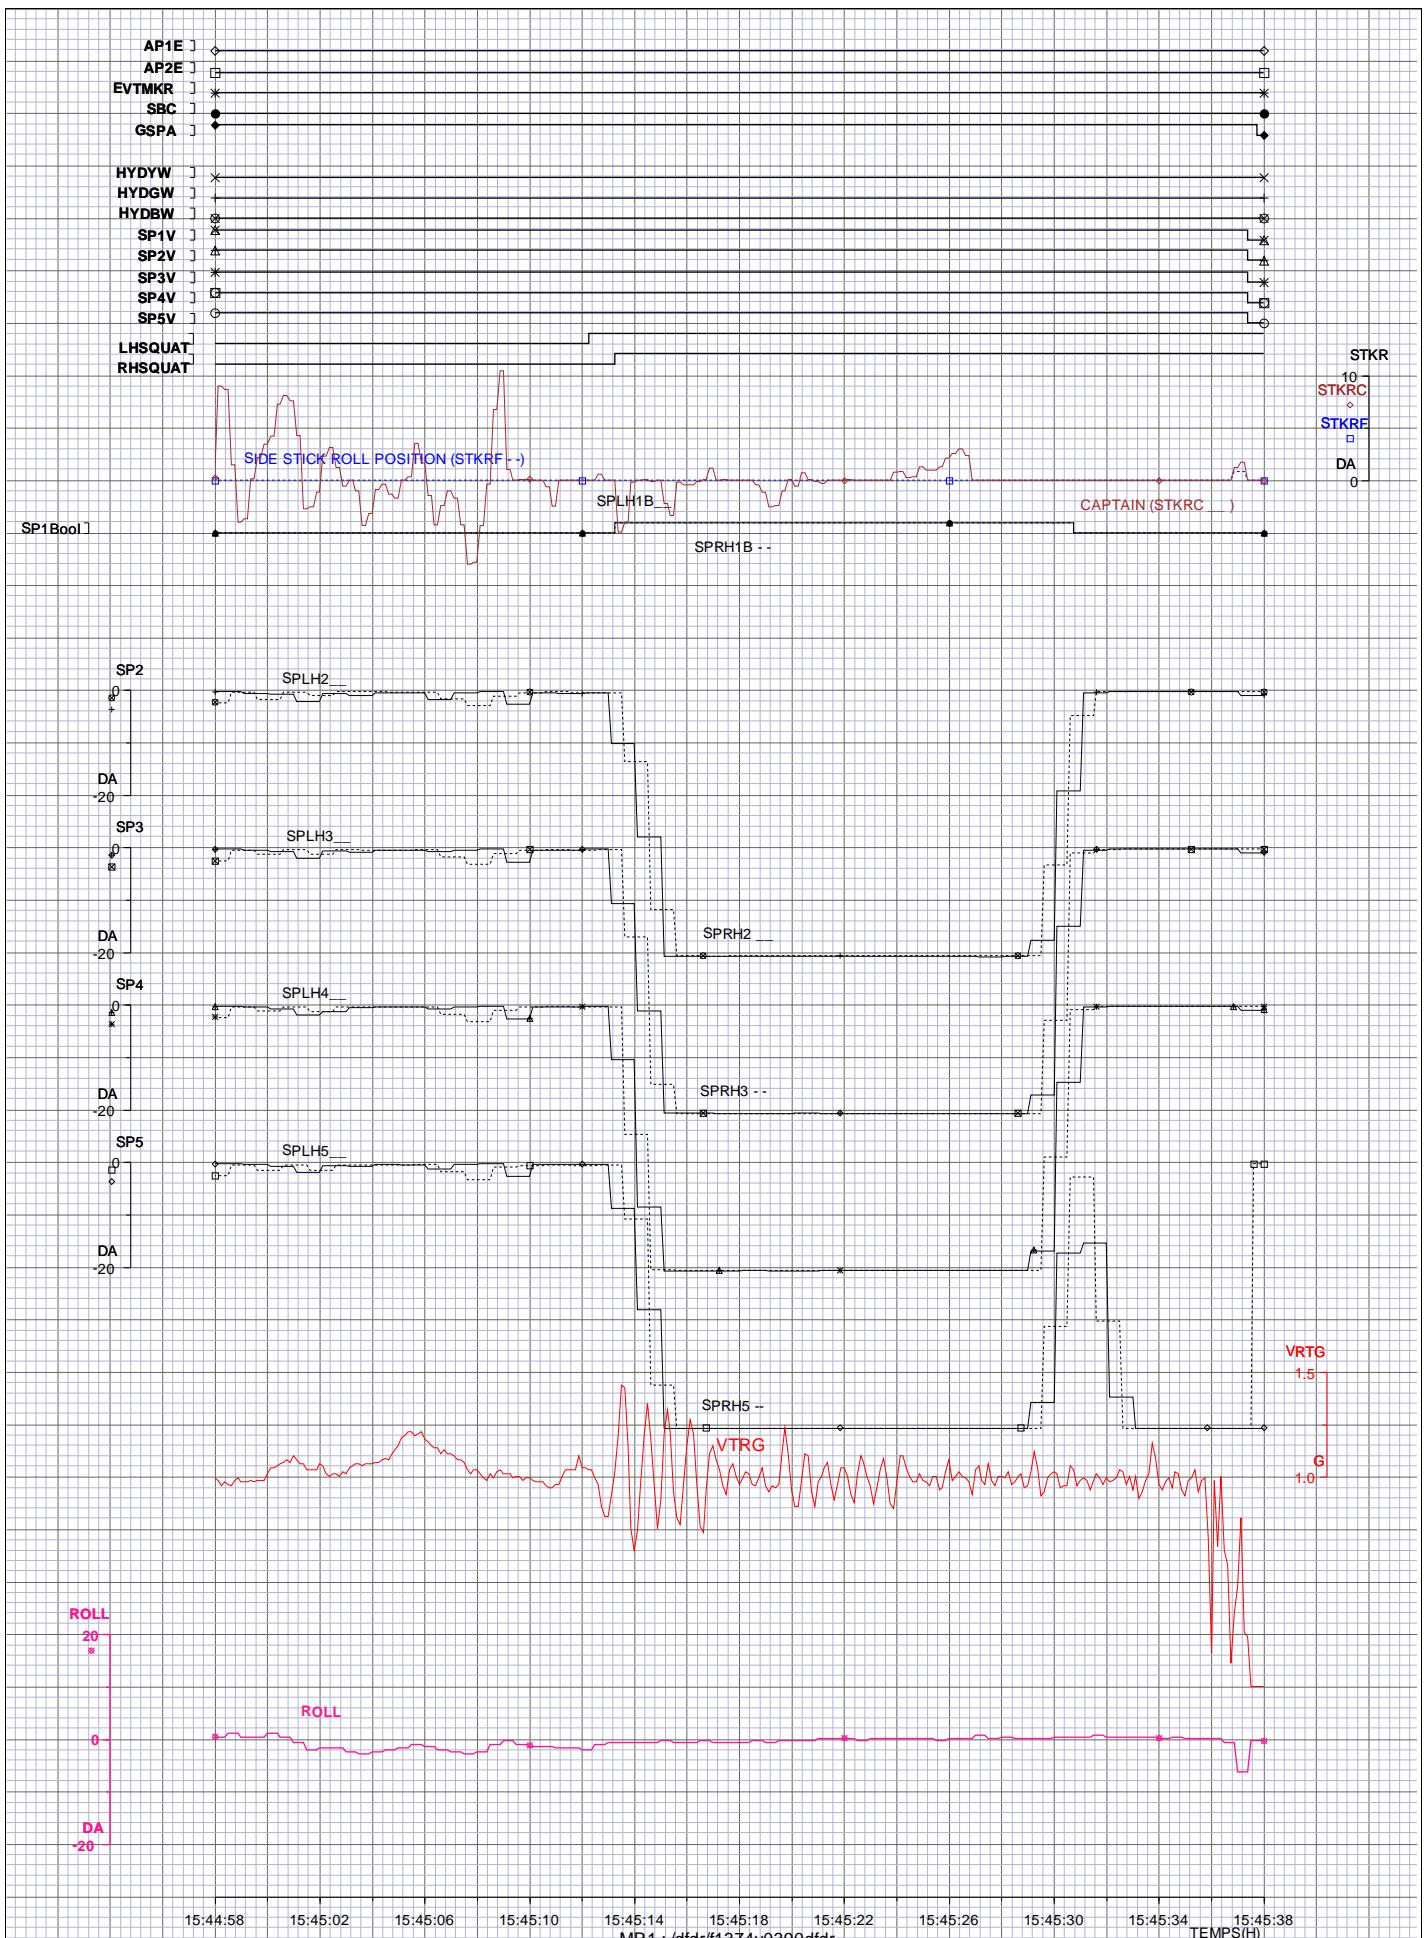
A/C :-	MSN 1374	No 0390	Integration Test Centre © AIRBUS
<b>SPOILERS</b>			
WGT (LBS) 140000.00	WGT (KG) 63503.88	/workgroup/operation/dfdr/visage/guillaume/F1374-RunwayExcursion/Spoilers.ilv	Edited : 4/6/2008 Figure 3.5

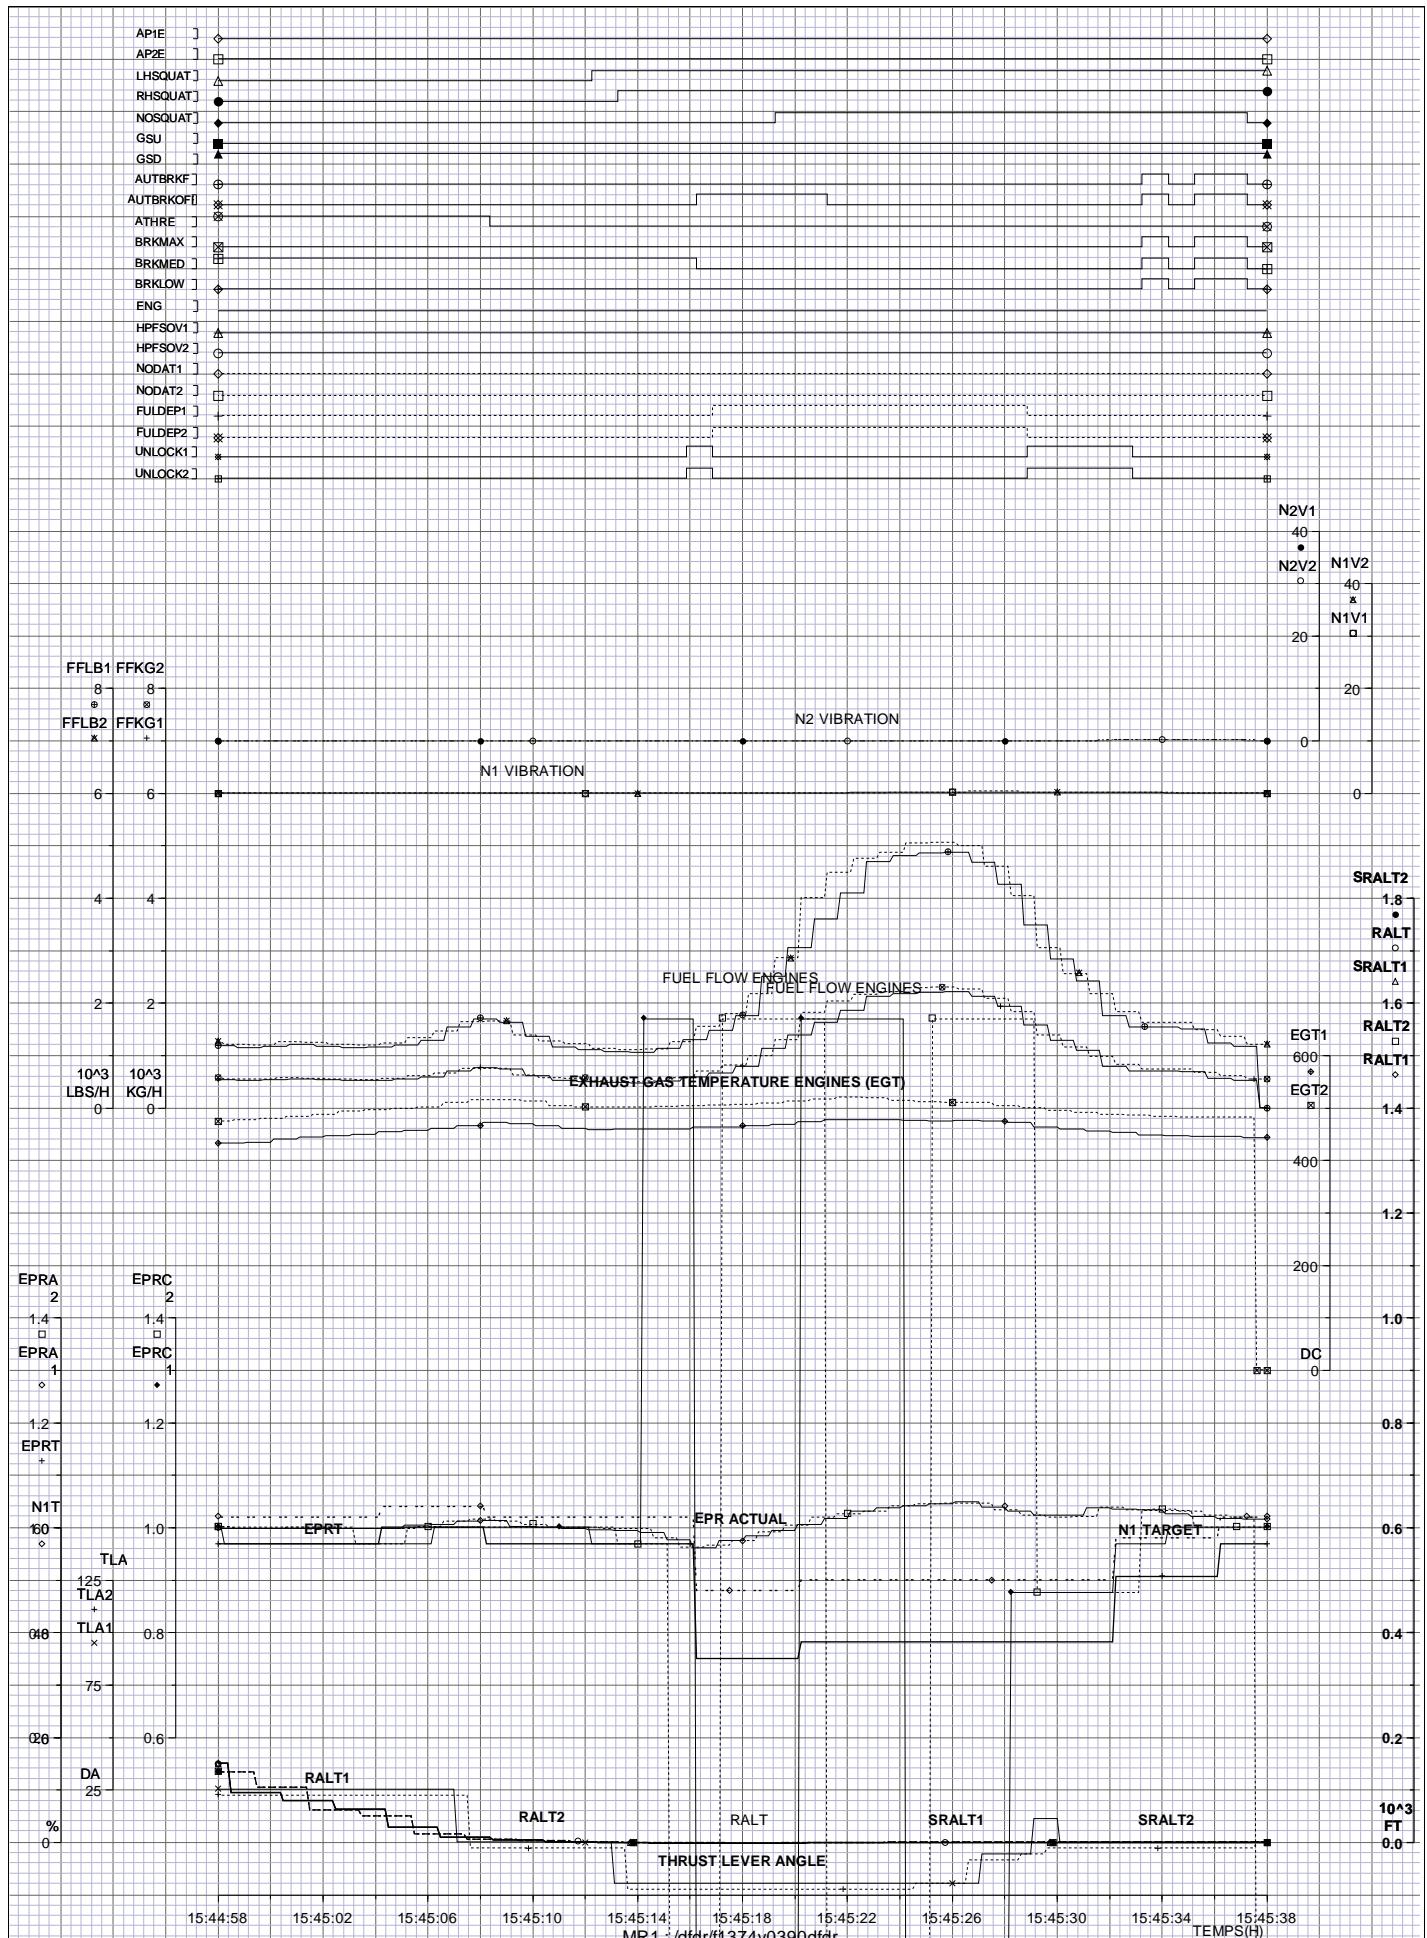
Figure 3.6

## ENGINE AND BRAKES BEHAVIOR

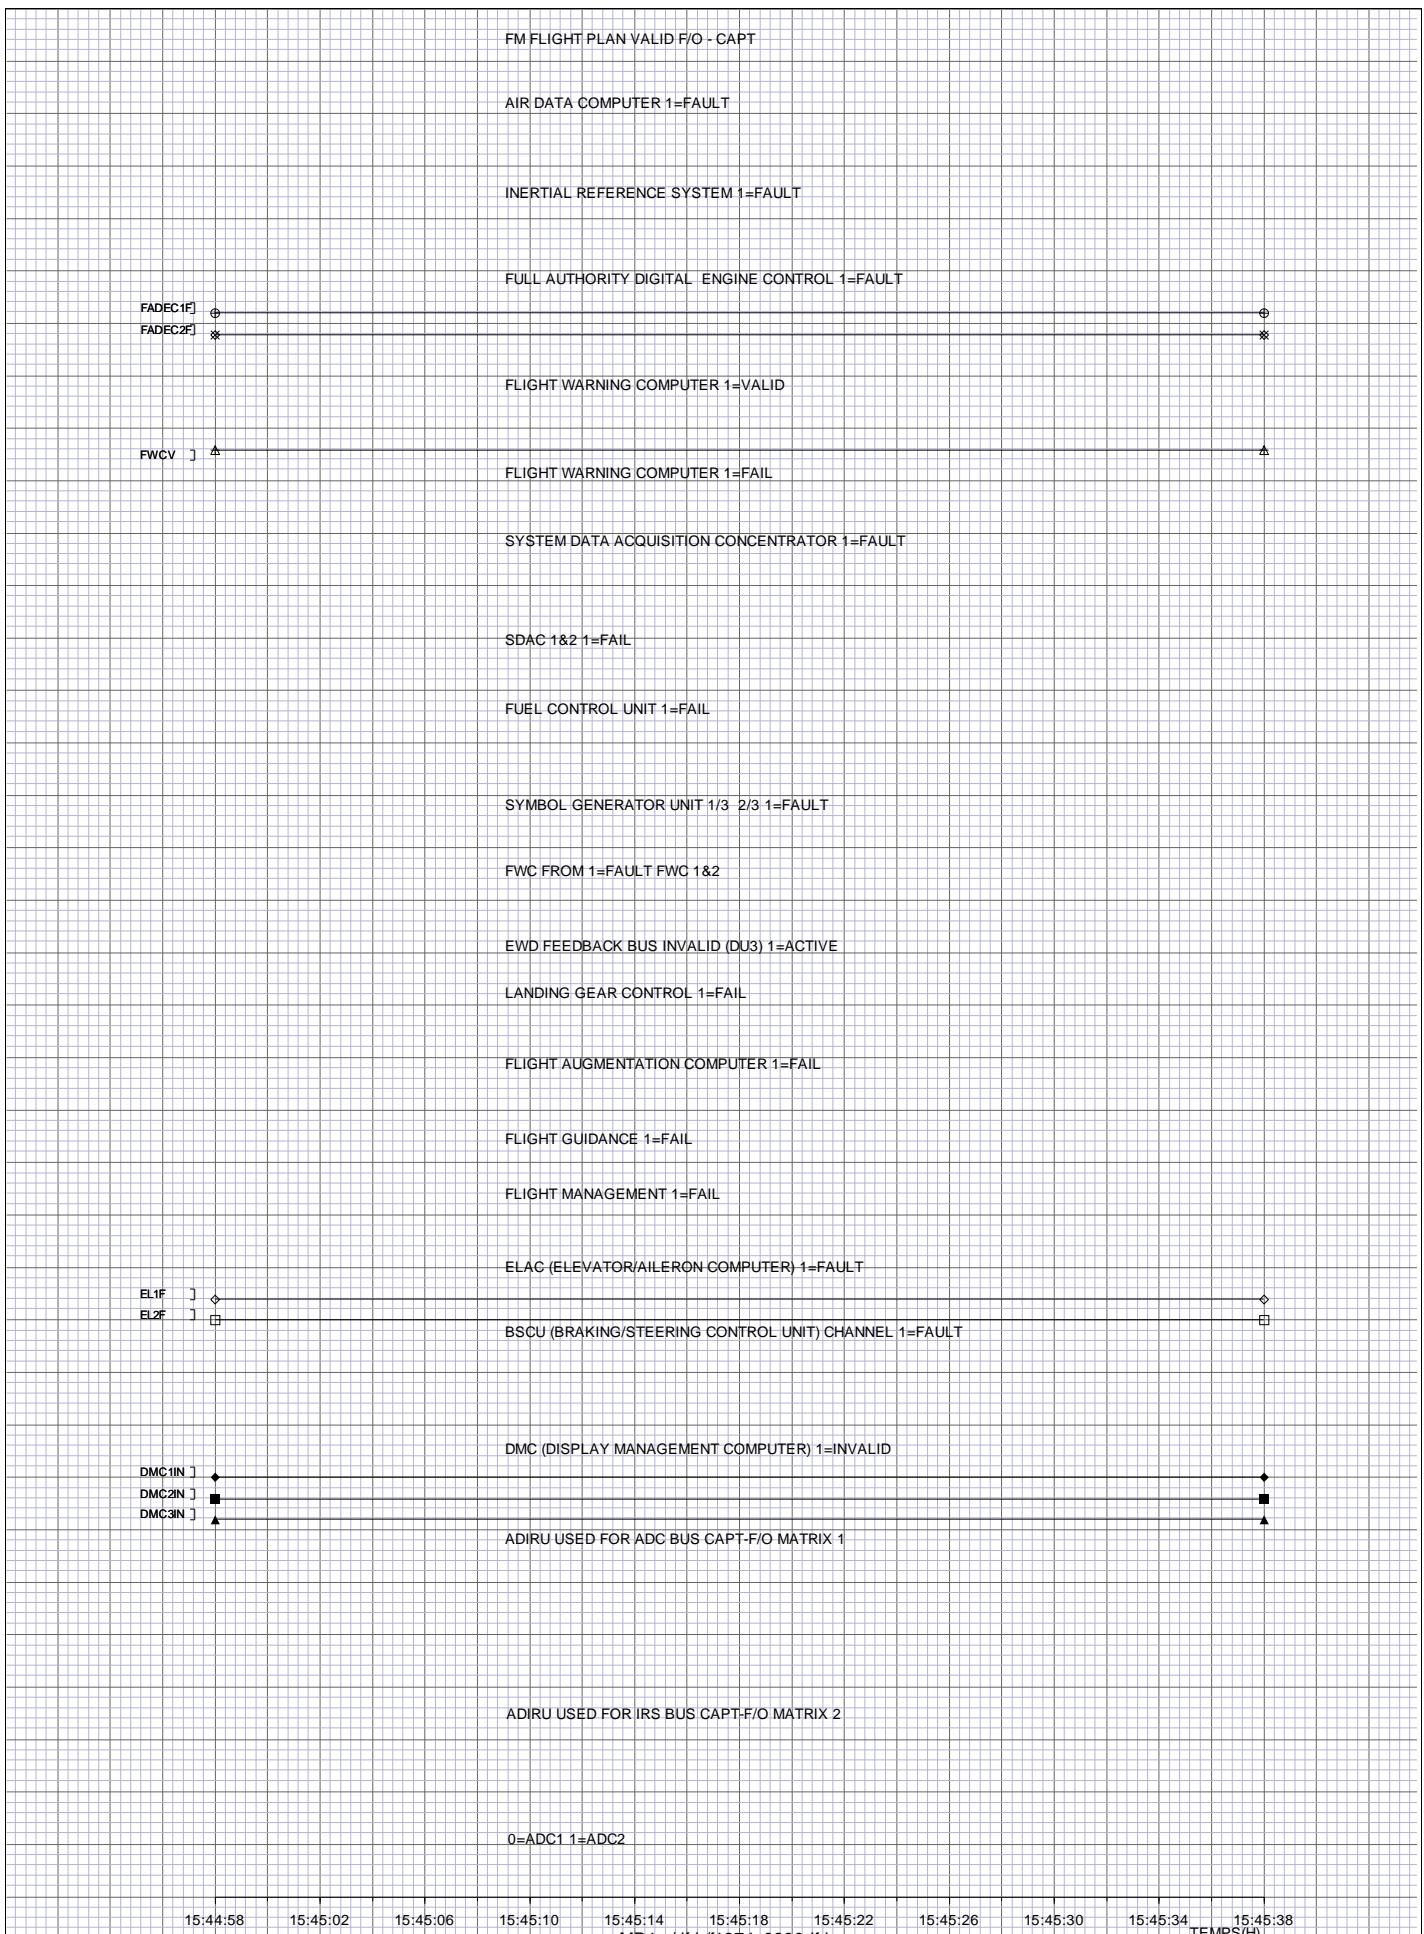
<b>Integration Test Centre</b>
<b>VALIDITY COMPUTERS AND CONFIGURATION</b>			
WGT(BS) 140000.00 Zoom WGT(KG) 63503.88			Edited : 4/6/2008
/workgroup/operation/dfdr/visage/guillaume/F1374-RunwayExcursion/Computers-ValidityConfig.ilv			Figure 3.7
